PIC/JB-26/61

## COMMUNICATIONS STATION

NEAR BAUTA, CUBA

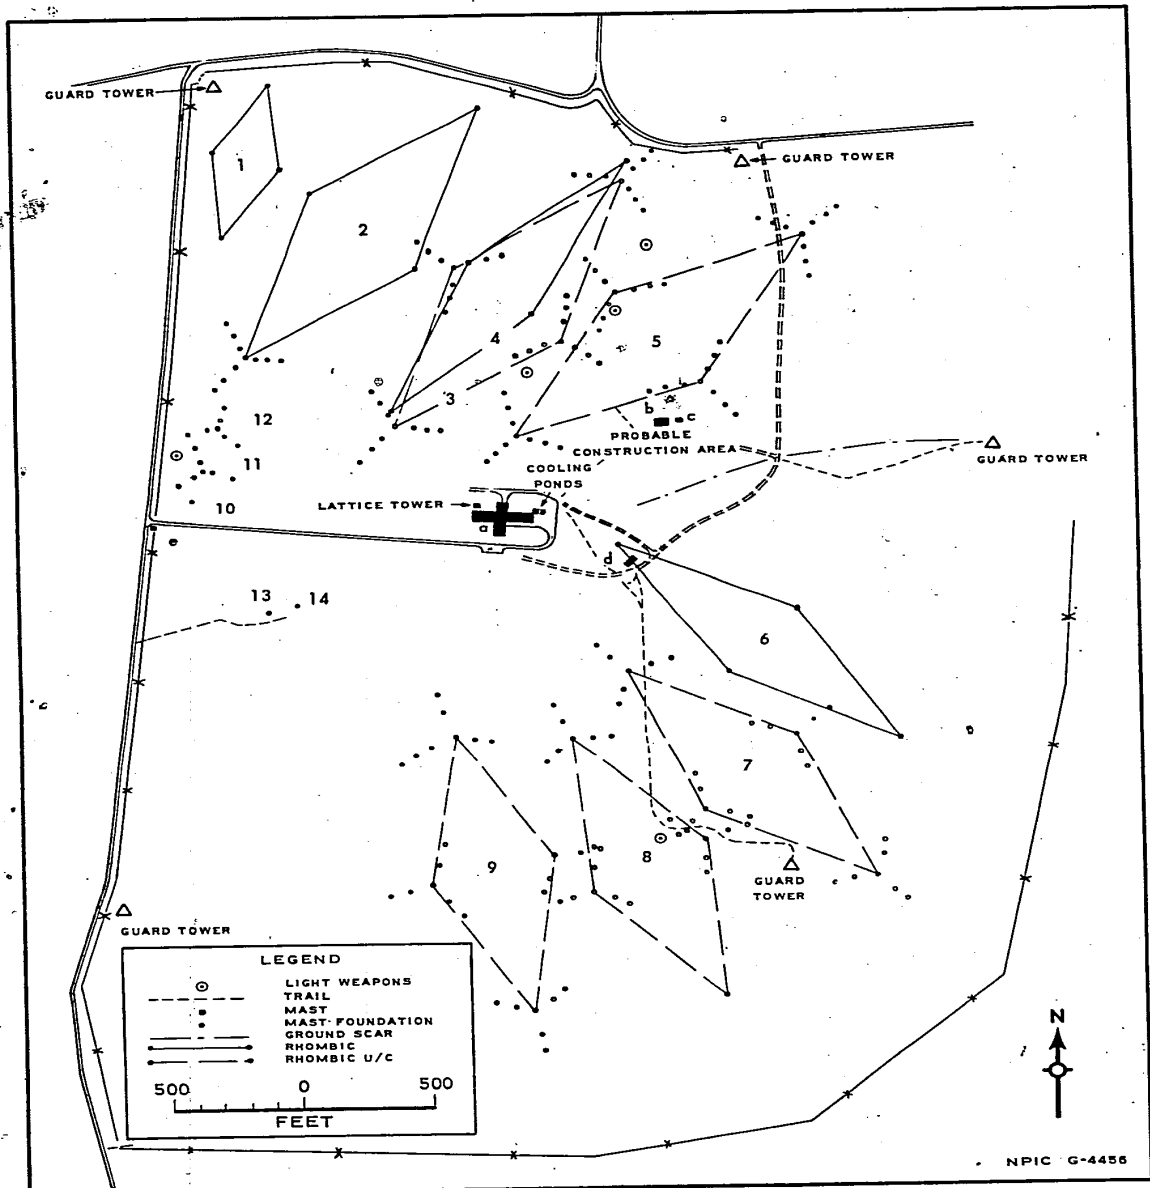
FIGURE 2. LAYOUT AND FACILITIES OF COMMUNICATIONS STATION NEAR BAUTA, CUBA.

25X1D A communications station near Bauta, Cuba, first observed on  
photography of [ ] is located at 22-57-00N 82-32-45W,  
3 kilometers (1.6 nautical miles) south of Bauta and 26 kilometers  
(14 nautical miles) southwest of Havana (see Figure 1). The station  
covers an area of approximately 340 acres. At the time of the latest  
25X1D photography [ ] security provisions included a perimeter  
fence under construction, five guard towers, and five light weapon  
positions, four of which were occupied (see Figure 2).

The station has nine rhombic antennas (four completed and five under construction). Rhombic 3, under construction, will replace No 4. All the rhombics are the four-pole type, except No 1, which is probably a bent rhombic. Rhombics 1-5 are oriented toward Europe and 6-9 toward South America. In the west part of the station area are five stick masts: a group of three and a pair. These masts probably support horizontal antennas. No feed or dissipation lines can be identified with any of the antennas. Antenna data are given in Tables 1 and 2 (item numbers are keyed to Figure 2).

Other buildings in the area include a security building, (item e), at the entrance, and three buildings (items b, c, and d) which appear to be associated with construction activity. Item b is 40 by 30 feet; c, 25 feet square; and d, 20 by 15 feet.

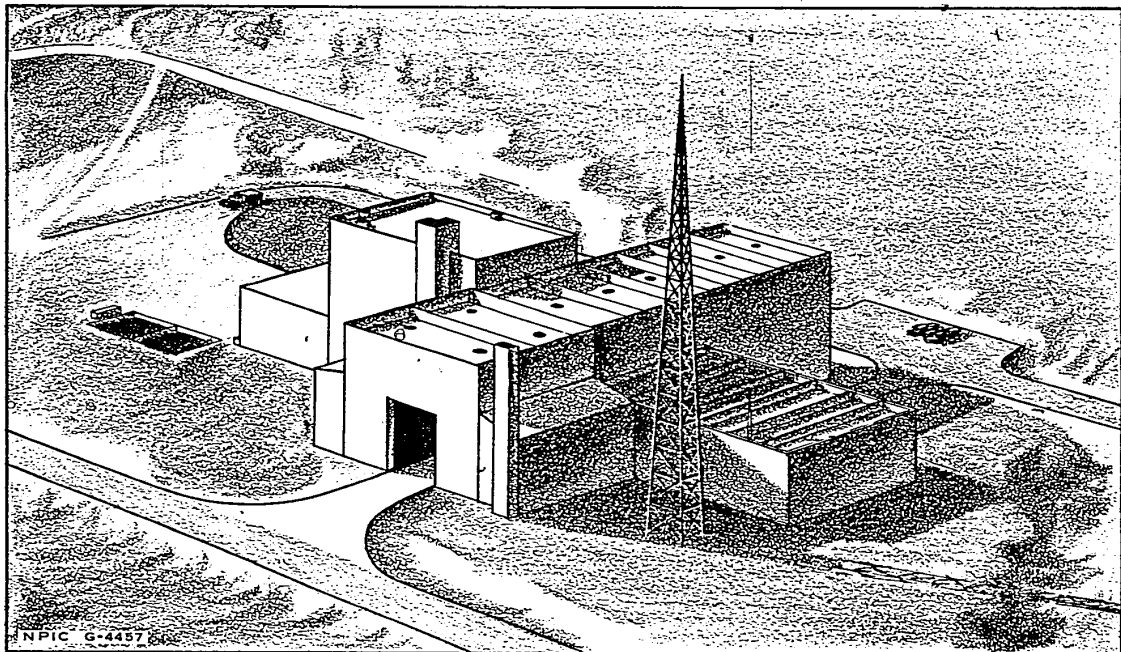
FIGURE 3. CONCEPT OF CONTROL BUILDING.

25X1B A cross-shaped control building (item a) is centrally located in the station area. It measures 190 by 150 feet and the center section is approximately 40 feet high (see Figure 3). The building is served by an all-weather road and has several adjacent parking areas. The

[ ]  
the roof of the control building appear to be water-holding basins. A 135-foot self-supporting lattice tower, possibly for local broadcasting and/or microwave relay, borders the northwest corner of the control building.
